**SERVICE BULLETIN RELEASE - 03/28/2014**

**05-005/14 – MULTI-MODEL (WITH SKYACTIV 6AT) - CHECK ENGINE LIGHT AND AUTOMATIC TRANSAXLE WARNING LIGHT ON WITH DTC P0842, P0847, P0872 AND/OR P0877 STORED IN TCM MEMORY**

<b>Subject:</b> CHECK ENGINE LIGHT AND AUTOMATIC TRANSAXLE WARNING LIGHT ON WITH DTC P0842, P0847, P0872 AND/OR P0877 STORED IN TCM MEMORY	<b>Bulletin No:</b> 05-005/14
	<b>Last Issued:</b> 03/28/2014

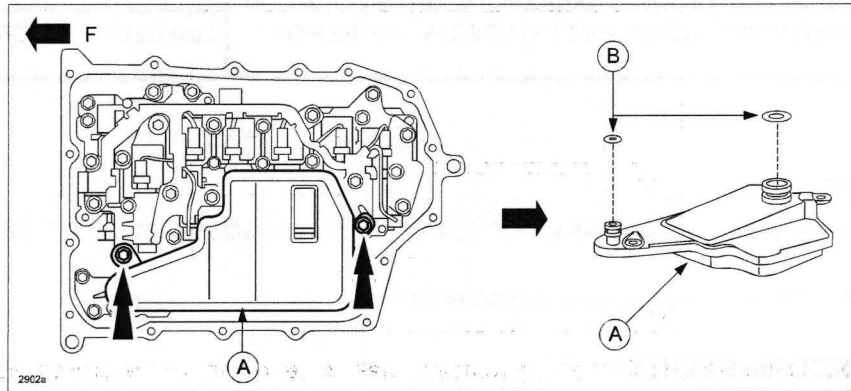
4. Remove the oil strainer (A) and the oil strainer O-rings (B) from the transaxle.  
F=Front of vehicle

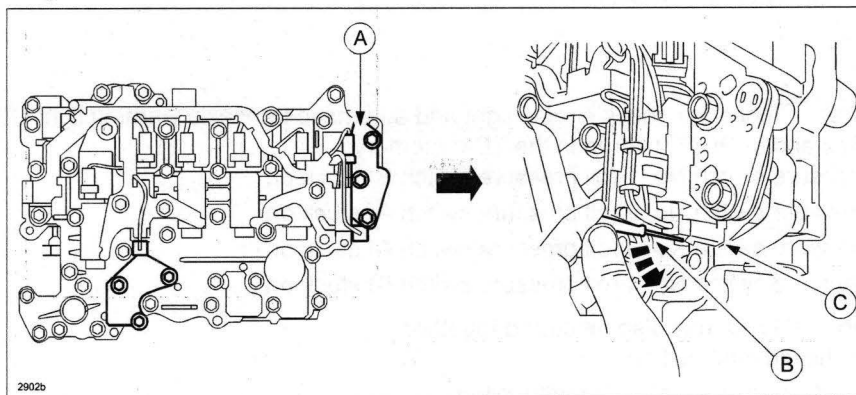
5. Remove oil pressure switch A.  
a. At oil pressure switch A, insert a precision flathead screwdriver (B) and move it in the direction of the arrow in the figure to disconnect the oil pressure switch A connector (C).

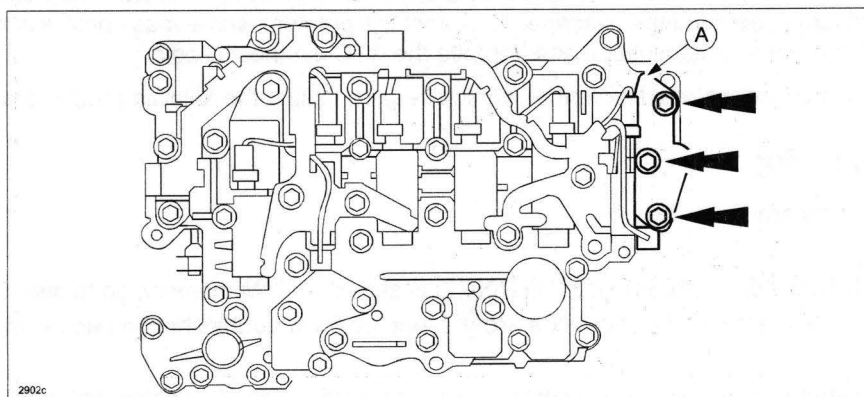
- b. Remove the bolts for oil pressure switch A.

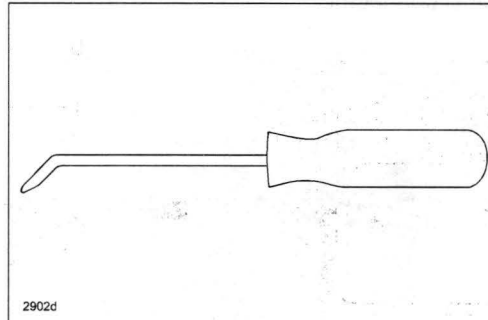
- c. Detach the tab shown and remove oil pressure switch A from the control valve body.
1. Using an appropriate tool (such as a fastener remover), push the tab (A) of oil pressure switch A.

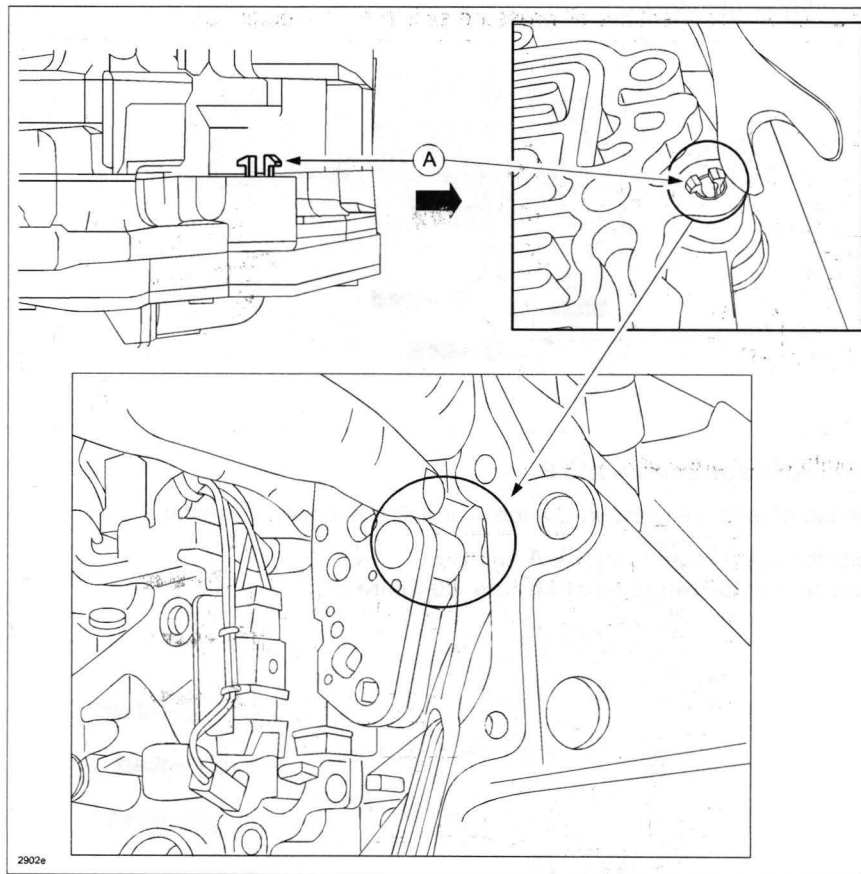
**CAUTION:** If the tab is broken during removal, make sure to remove the broken pieces.

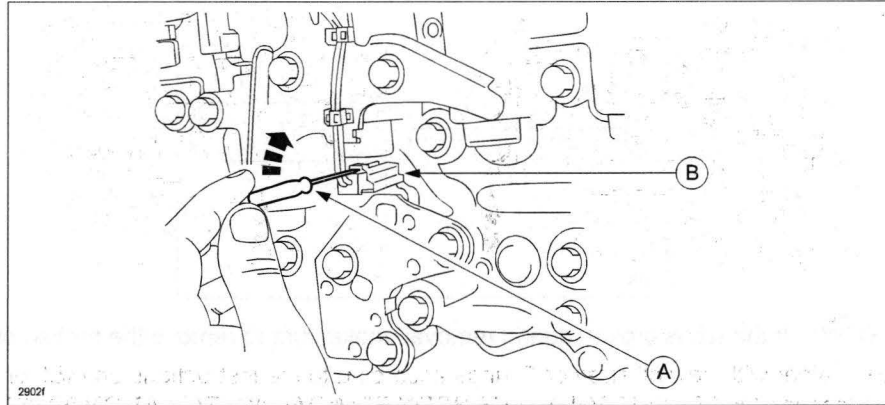
6. Remove oil pressure switch B.
  - a. Insert a precision flathead screwdriver (A) and move it in the direction of the arrow as shown to disconnect the oil pressure switch B connector.

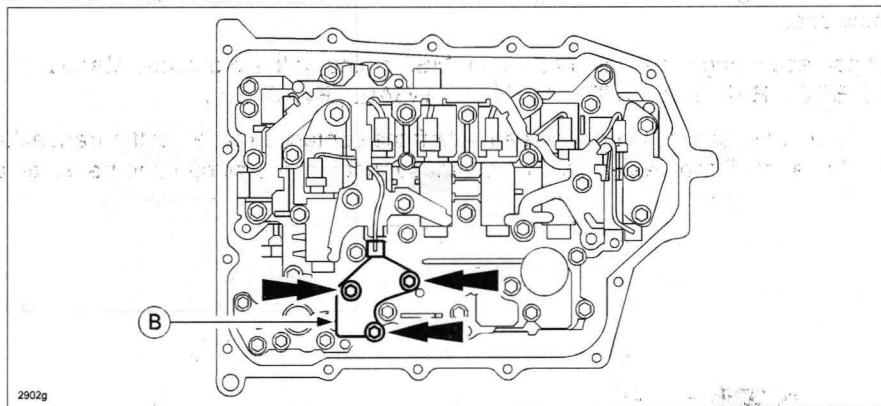
- b. Remove oil pressure switch B.

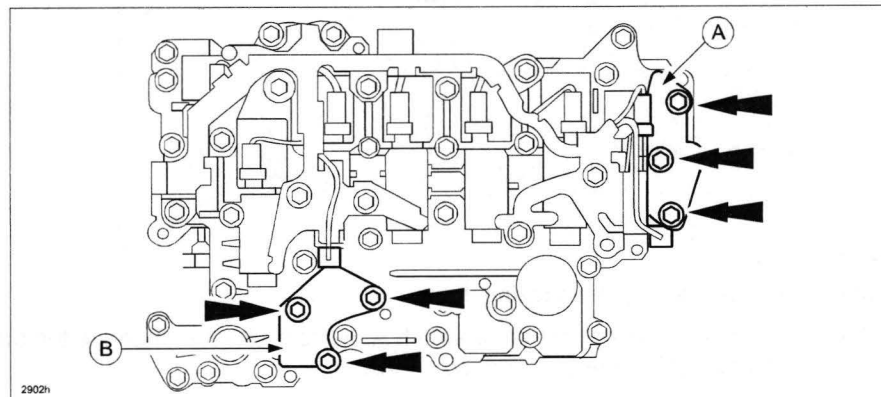
7. Install new oil pressure switches A and B.
8. Verify that the tab of each oil pressure switch A and B is attached correctly.
9. Install the bolts for oil pressure switches A and B.  
**Tightening torque: 9-10 N•m {92-101 khf•cm, 80-88 in•lbf}**

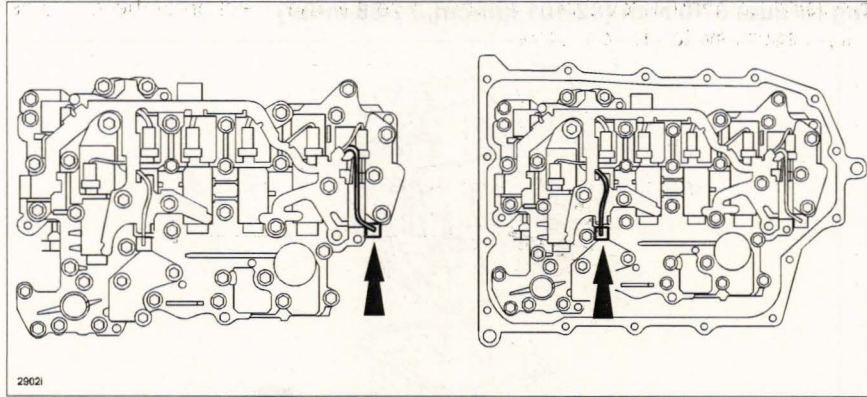
10. Connect the oil pressure switches A and B connectors.

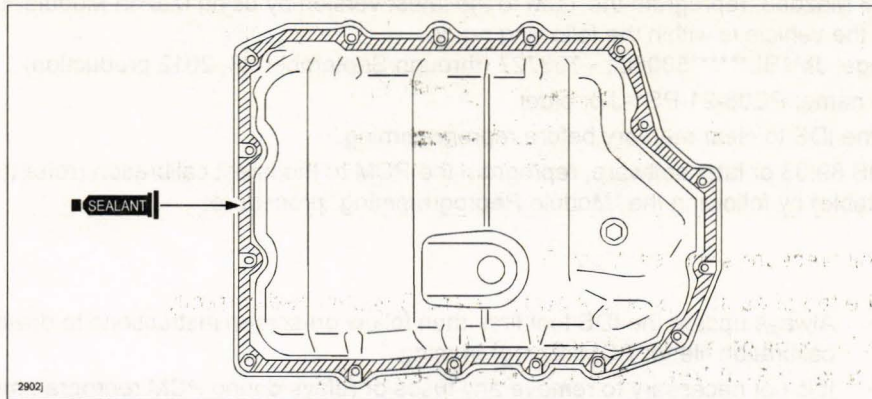
**CAUTION:** Clean any remaining silicone sealant off the contact surfaces of the transaxle case and oil pan.  
a. Apply a light coat of silicon sealant to the contact surfaces of the oil pan and transaxle case.

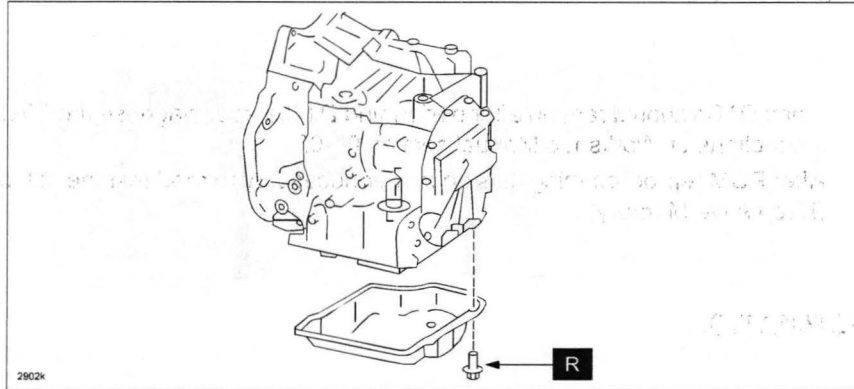
- b. Install the oil pan with new bolts before the applied sealant starts to harden.

**Tightening torque: 8-10 N•m {82-101 khf•cm, 71-88 in•lbf}**
