## A Closer Look at the Toyota A750E Valve Body

by Mike Brown members.atra.com

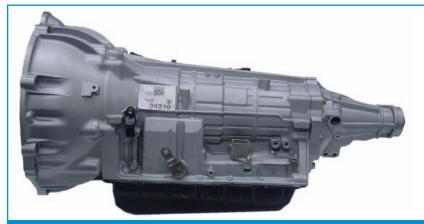
Figure 1

A750E (2WD)/A750F (4WD)  Gear Ratios		
1st	3.52	
2nd	2.042	
3rd	1.4	
4th	1	
5th	0.716	
Reverse	3.224

These transmissions have been on the road for up to seven years and are getting a lot of miles on them. With all the cars using this transmission, there's no doubt you'll be seeing it in the years to come (figure 1).

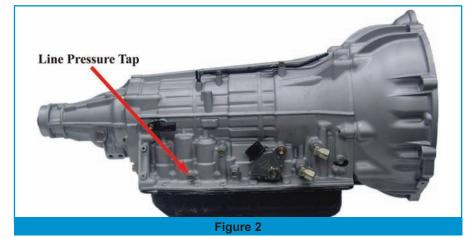
Line pressure tap location and

A750E/F Line Pressure Specifications			
Condition	D Position	R Position	
ldling	53-59 psi	73-84 psi	
Stall	196-212 psi	188-205 psi

specifications (figure 2).

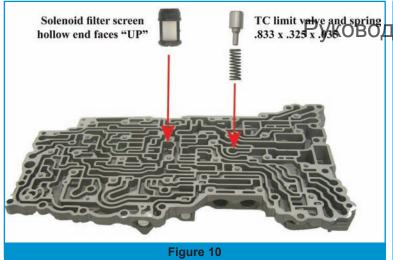
Always install the solenoid filter screen (figure 10) with the open end up. The screen will snap into the separator plate when properly installed. Install the torque converter check valve as shown.

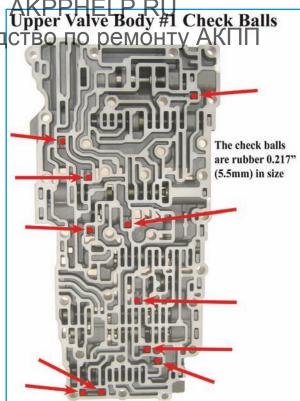
Figure 11

There are three sections to the A750E/F valve body. Upper valve bodies 1 and 2 are the only valve bodies with checkballs (figures 11 and 12).

All of the checkballs are composite. Make sure the checkballs are in good shape; replace any that are damaged or have decomposed. All of the checkballs are the same size: 0.217" (5.5mm).

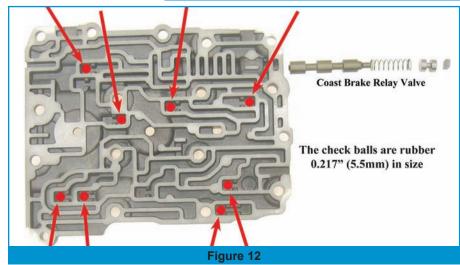
The coast brake relay valve is located in upper valve body 2 (figure 12). Be sure to remove, clean and inspect this valve body.

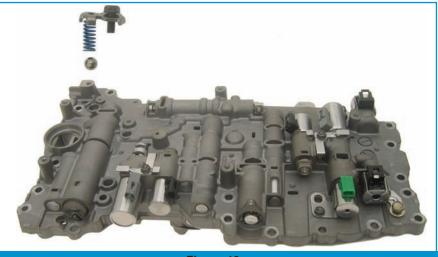
Figure 13

The purpose of the pressure limit checkball is to exhaust pressure if it becomes too high (figure 13). The limit valve will blow off at about 300 PSI.
